# Cooperative Planning for Source Water Protection: Targeting Sediment in the Upper Saluda River Watershed

**ABSTRACT.** Save Our Saluda, in cooperation with partnering organizations, is developing a watershed plan to address sediment in the North Saluda River and Saluda Lake. The plan lays the groundwork for implementation of practices and measures to help reduce sediment runoff and stabilize streambanks to improve and protect the health of the river and lake. The project is funded through the South Carolina Department of Health and Environmental Control (SCDHEC) Nonpoint Source Program with support from the partnership.

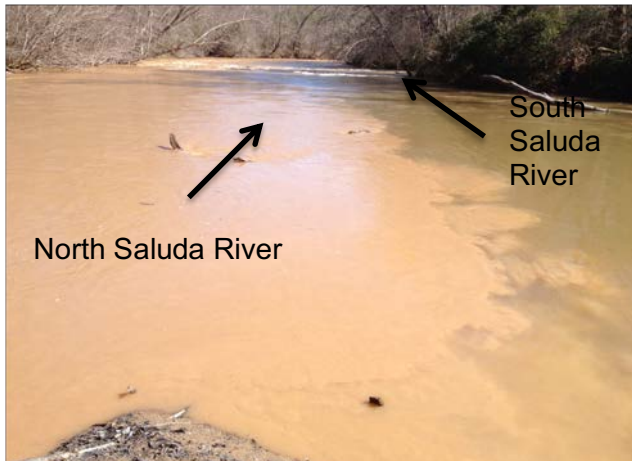
**Figure 2. North-South Saluda Rivers Confluence**

upstream is impaired, aquatic habitat is degraded, and recreation is diminished due to sedimentation, particularly in the North Saluda River (Figure 2).
